## De-frosting the side light/indicator pod

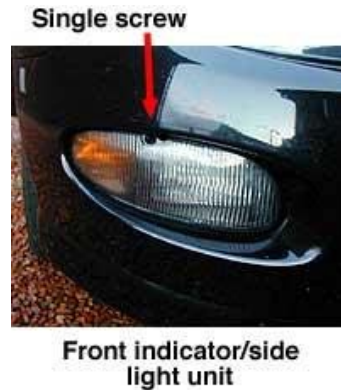
Undo the screw marked in the picture. There are 2 screws here, one that looks like a screw, and one that looks more like a bolt. The bolt one is to adjust the angle of the light pod and shouldn't be touched. Remove the screw and jiggle the light pod out, pushing it from behind by putting your hand up under the bumper through a hole just under the pod. It will come out with a little work. Detach the wires.
